Rolls-Royce Senior Design 2015

Design Objective

To induce, detect, and diagnose three distinct degraded conditions on the final control elements of a pneumatic control valve.

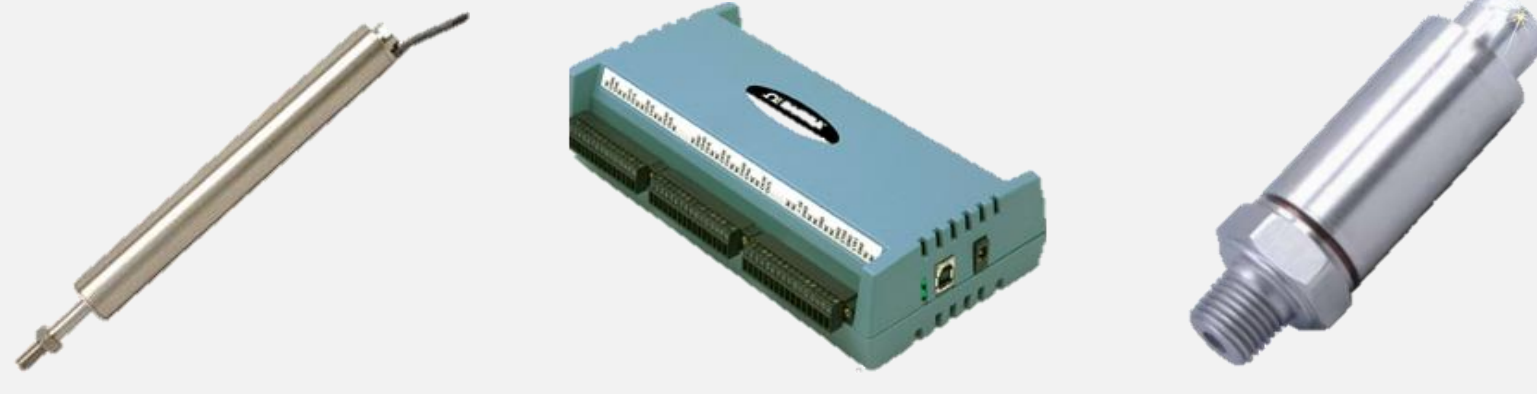
Hardware

- OMB-DAQ-2416
- 2 J-Type Thermocouples
- OMEGA PX309-500G5V
- OMEGA LD620-25

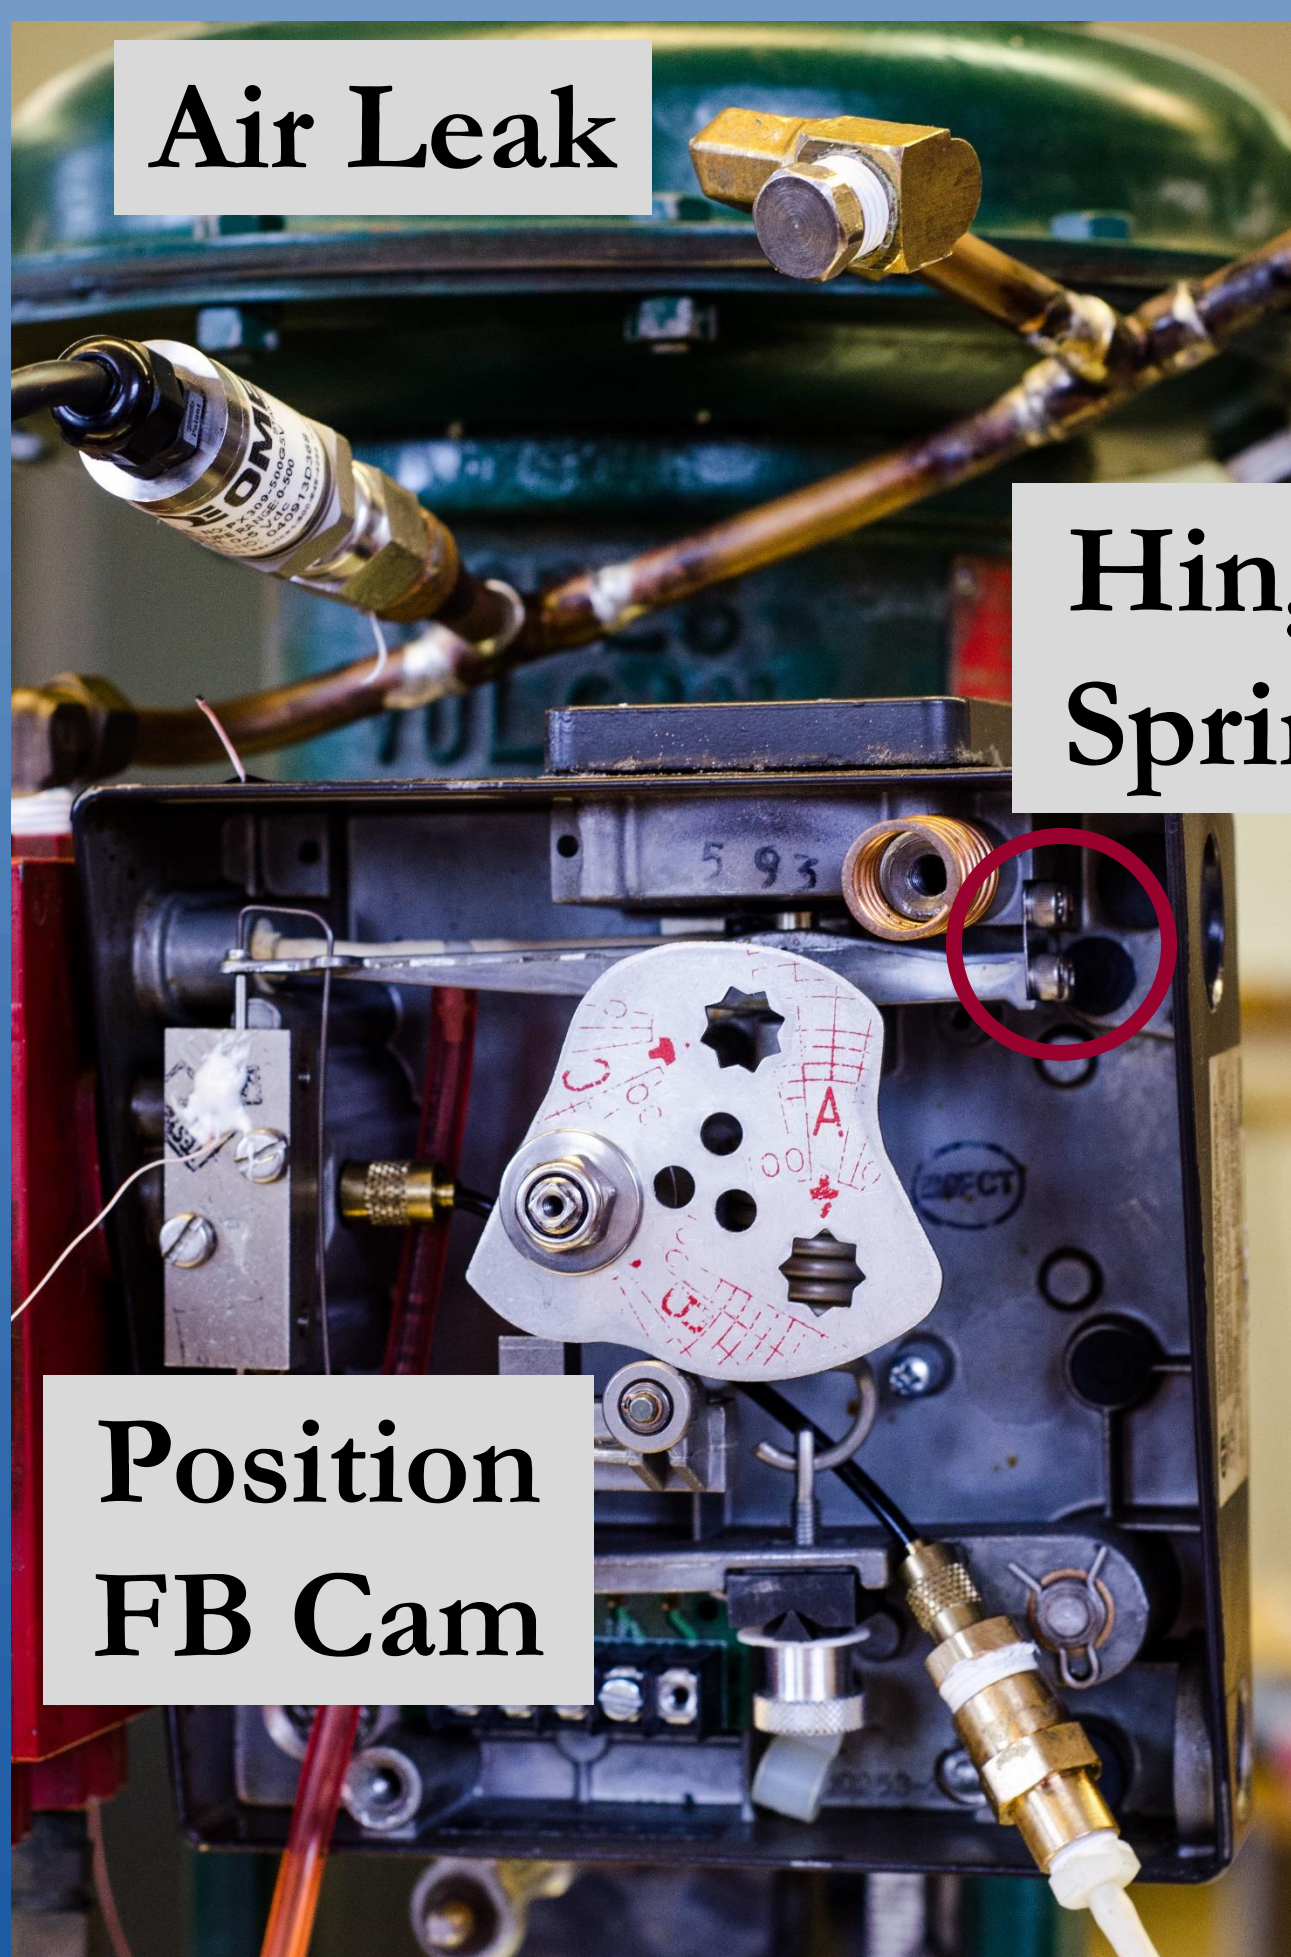
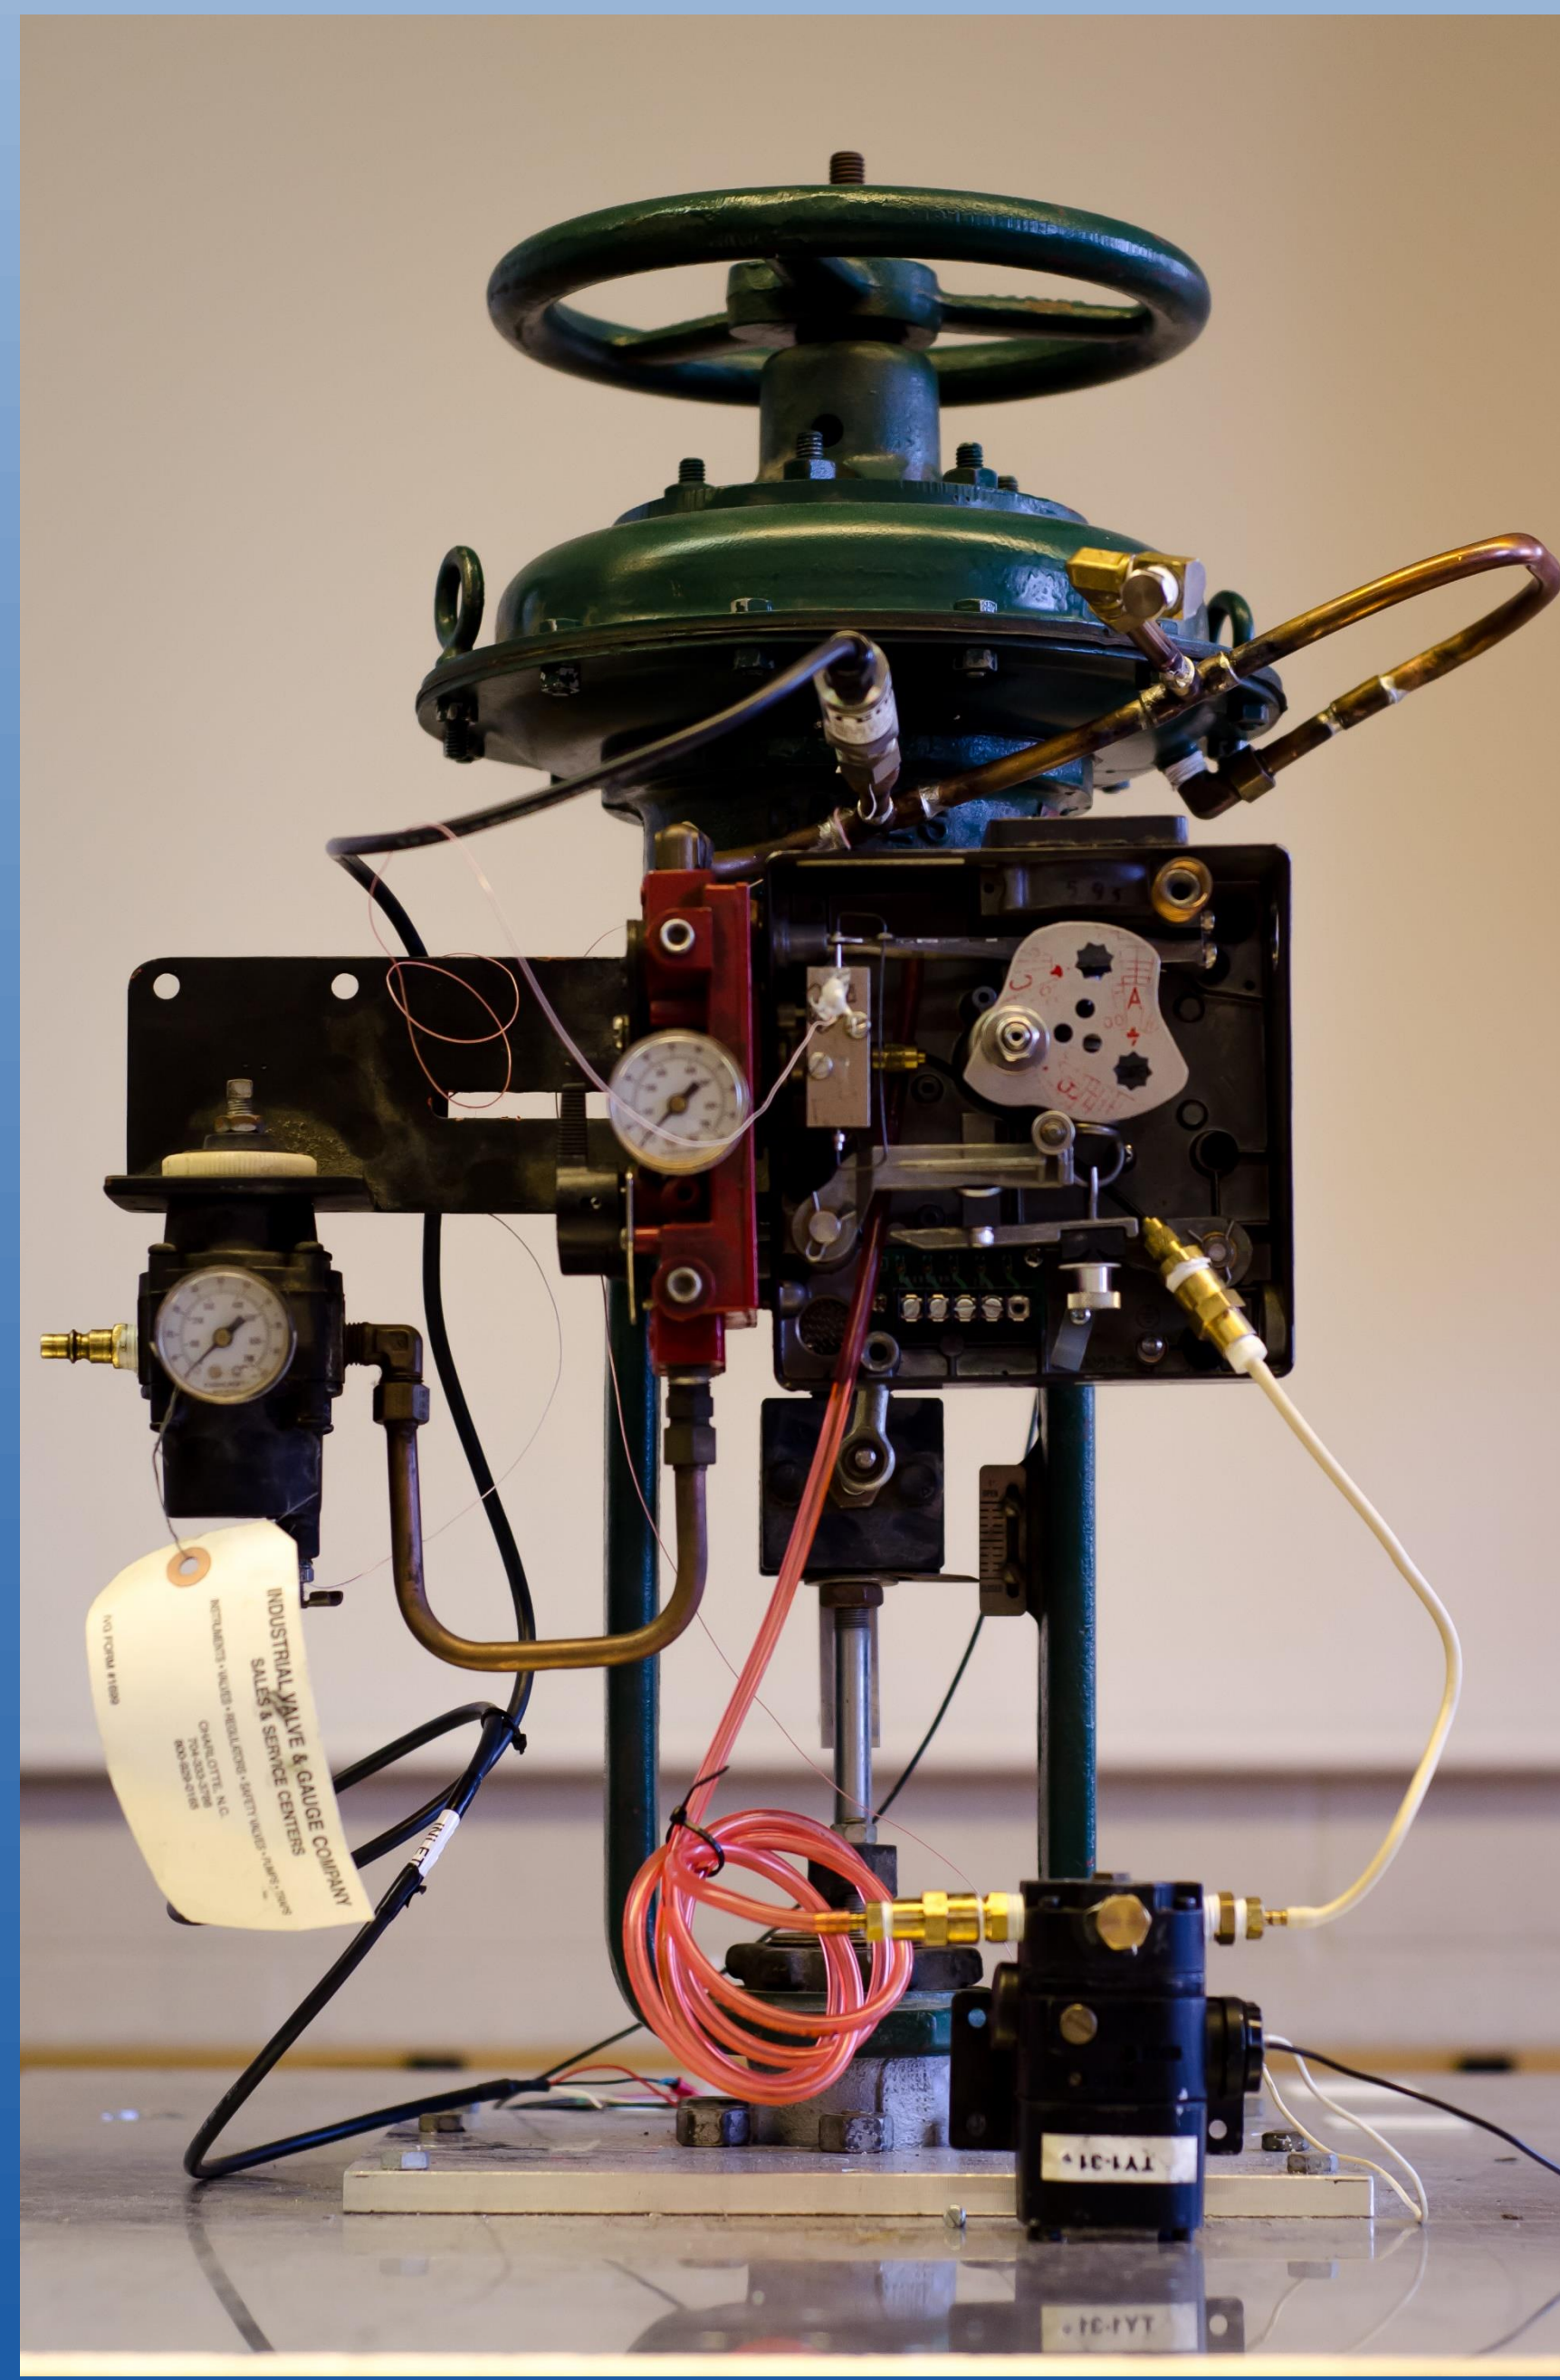
Degraded Conditions

Degraded conditions were artificially induced in three locations known to fail on a pneumatic control valve: an air leak on the pressure line connecting the positioner to the actuator, wear on the gain hinge spring, and worn edges on the position feedback cam.

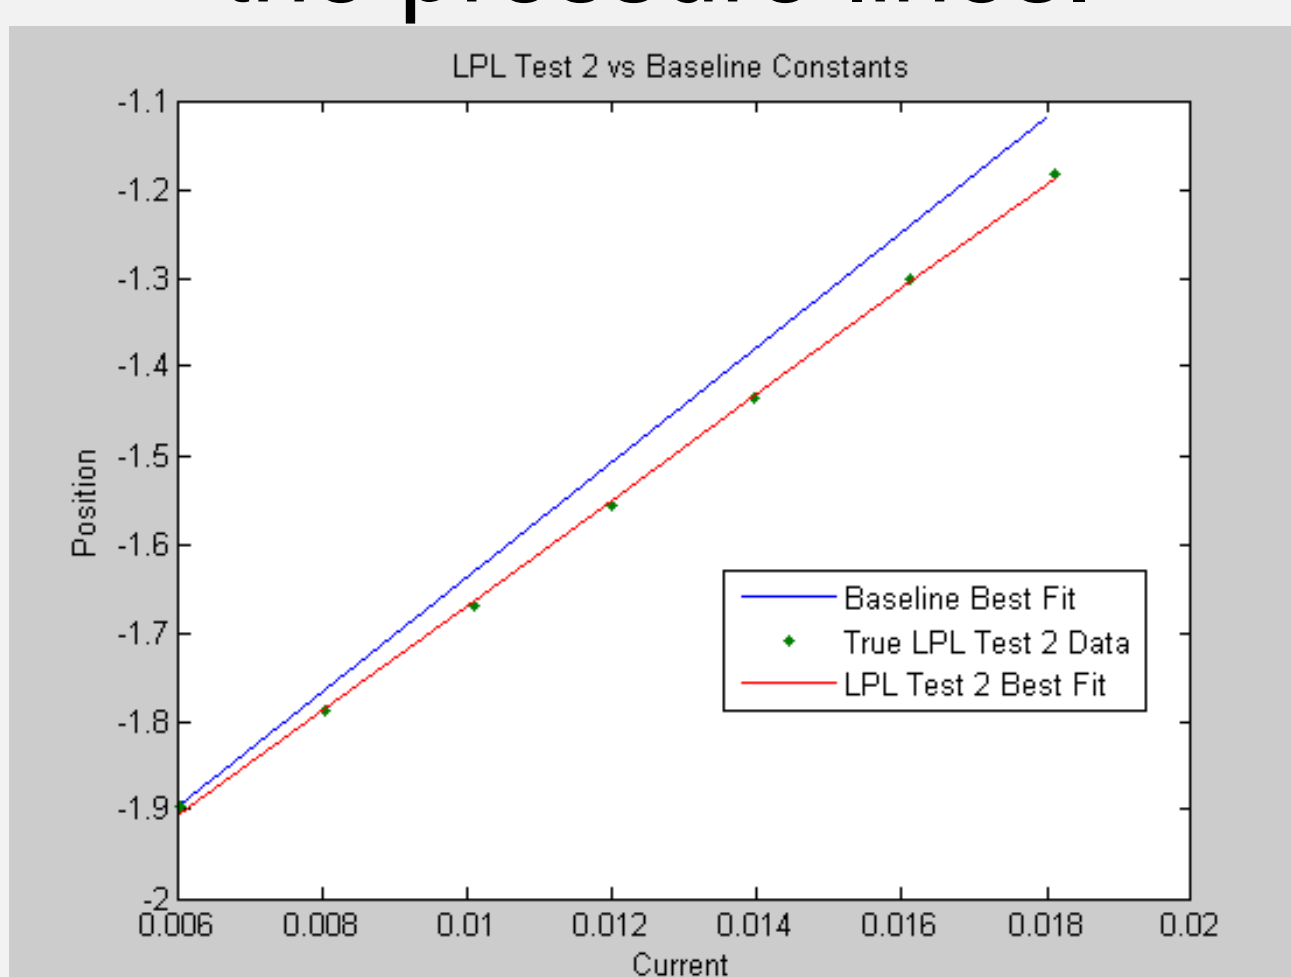
Air Leak Results

Failure was best detected by linearly modeling slopes the slopes of position and / or pressure vs. voltage. Smaller slopes correlate to larger leaks in the pressure lines.

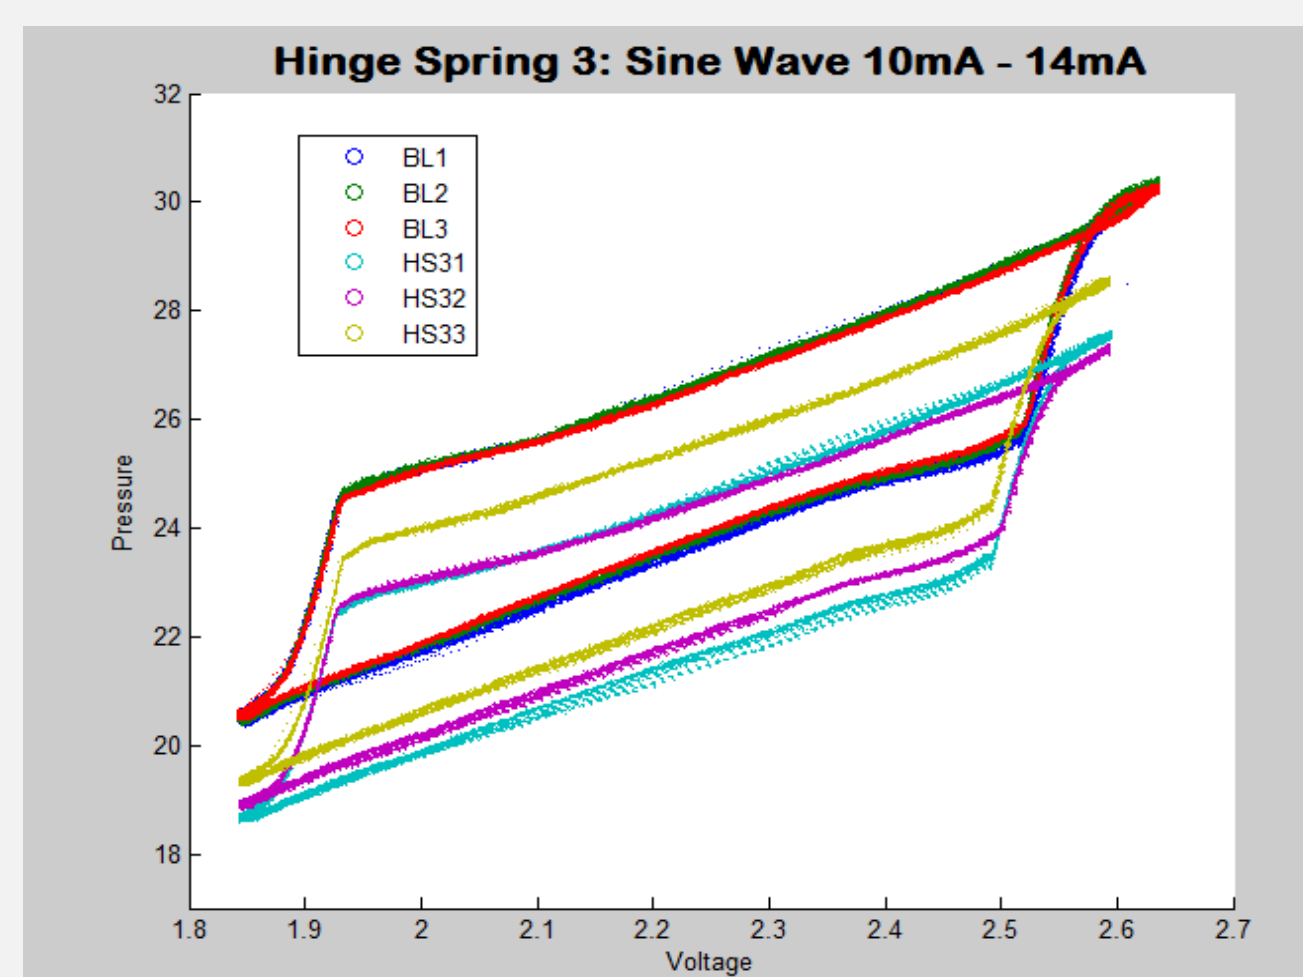
Hinge Spring Results

Failure in the hinge spring was detected when analyzing position vs. voltage and pressure vs. voltage. In this case the pressure and position were shifted down.

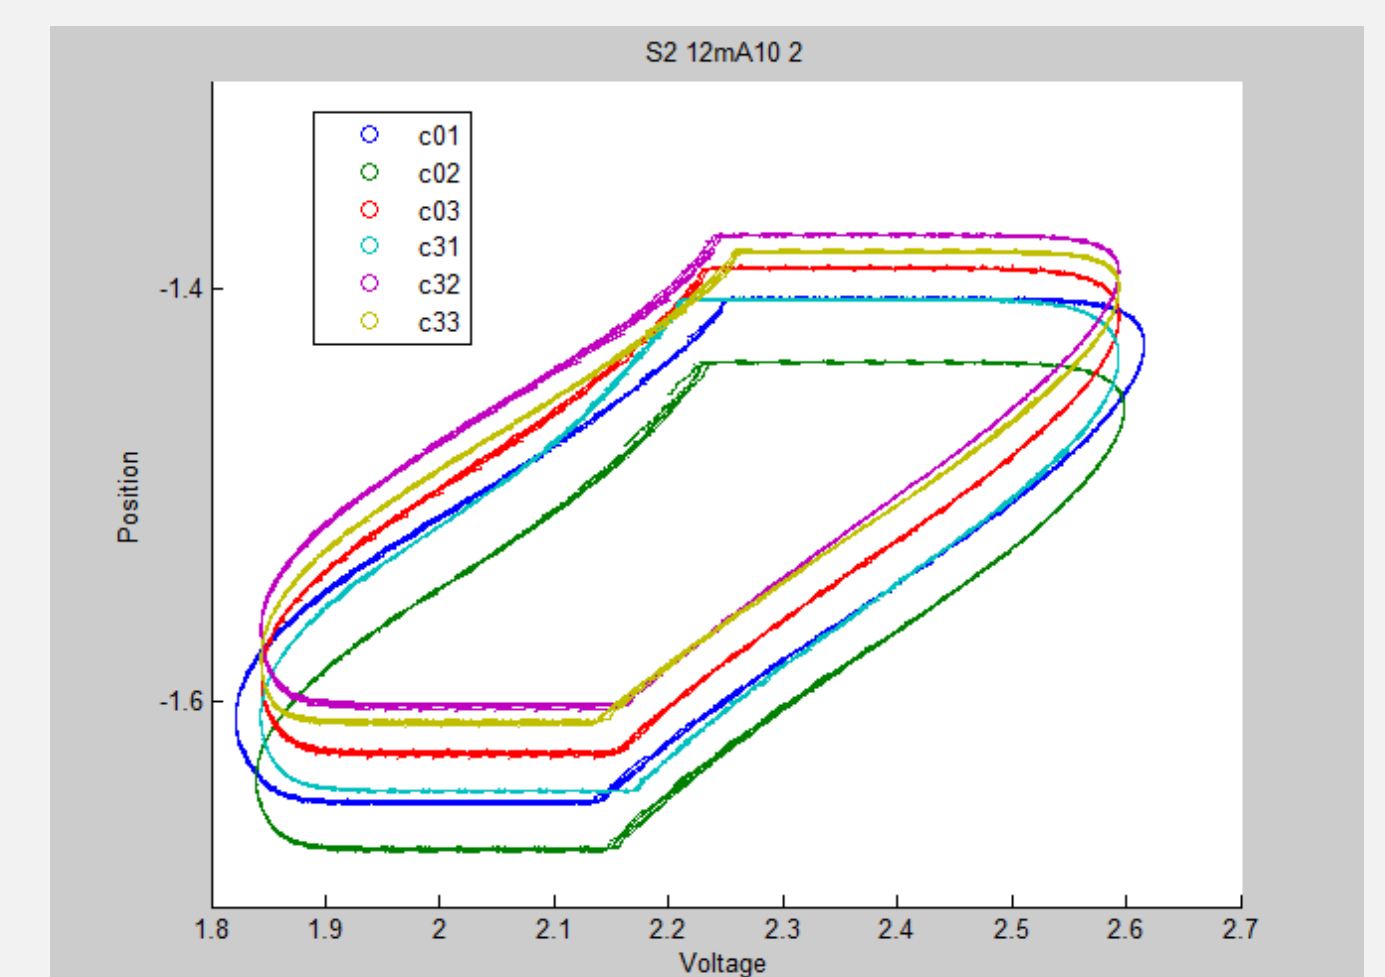
Cam Wear Results

Tests regarding cam wear were determined to be inconclusive.
